Debris/Ice/TPS Assessment and Integrated Photographic Analysis for Shuttle Mission STS-60

DEBRIS/ICE/TPS ASSESSMENT
AND
INTEGRATED PHOTOGRAPHIC ANALYSIS
OF
SHUTTLE MISSION STS-60

February 3, 1994

Shuttle Mission STS-60 was launched at 7:10 a.m. local 2/3/94

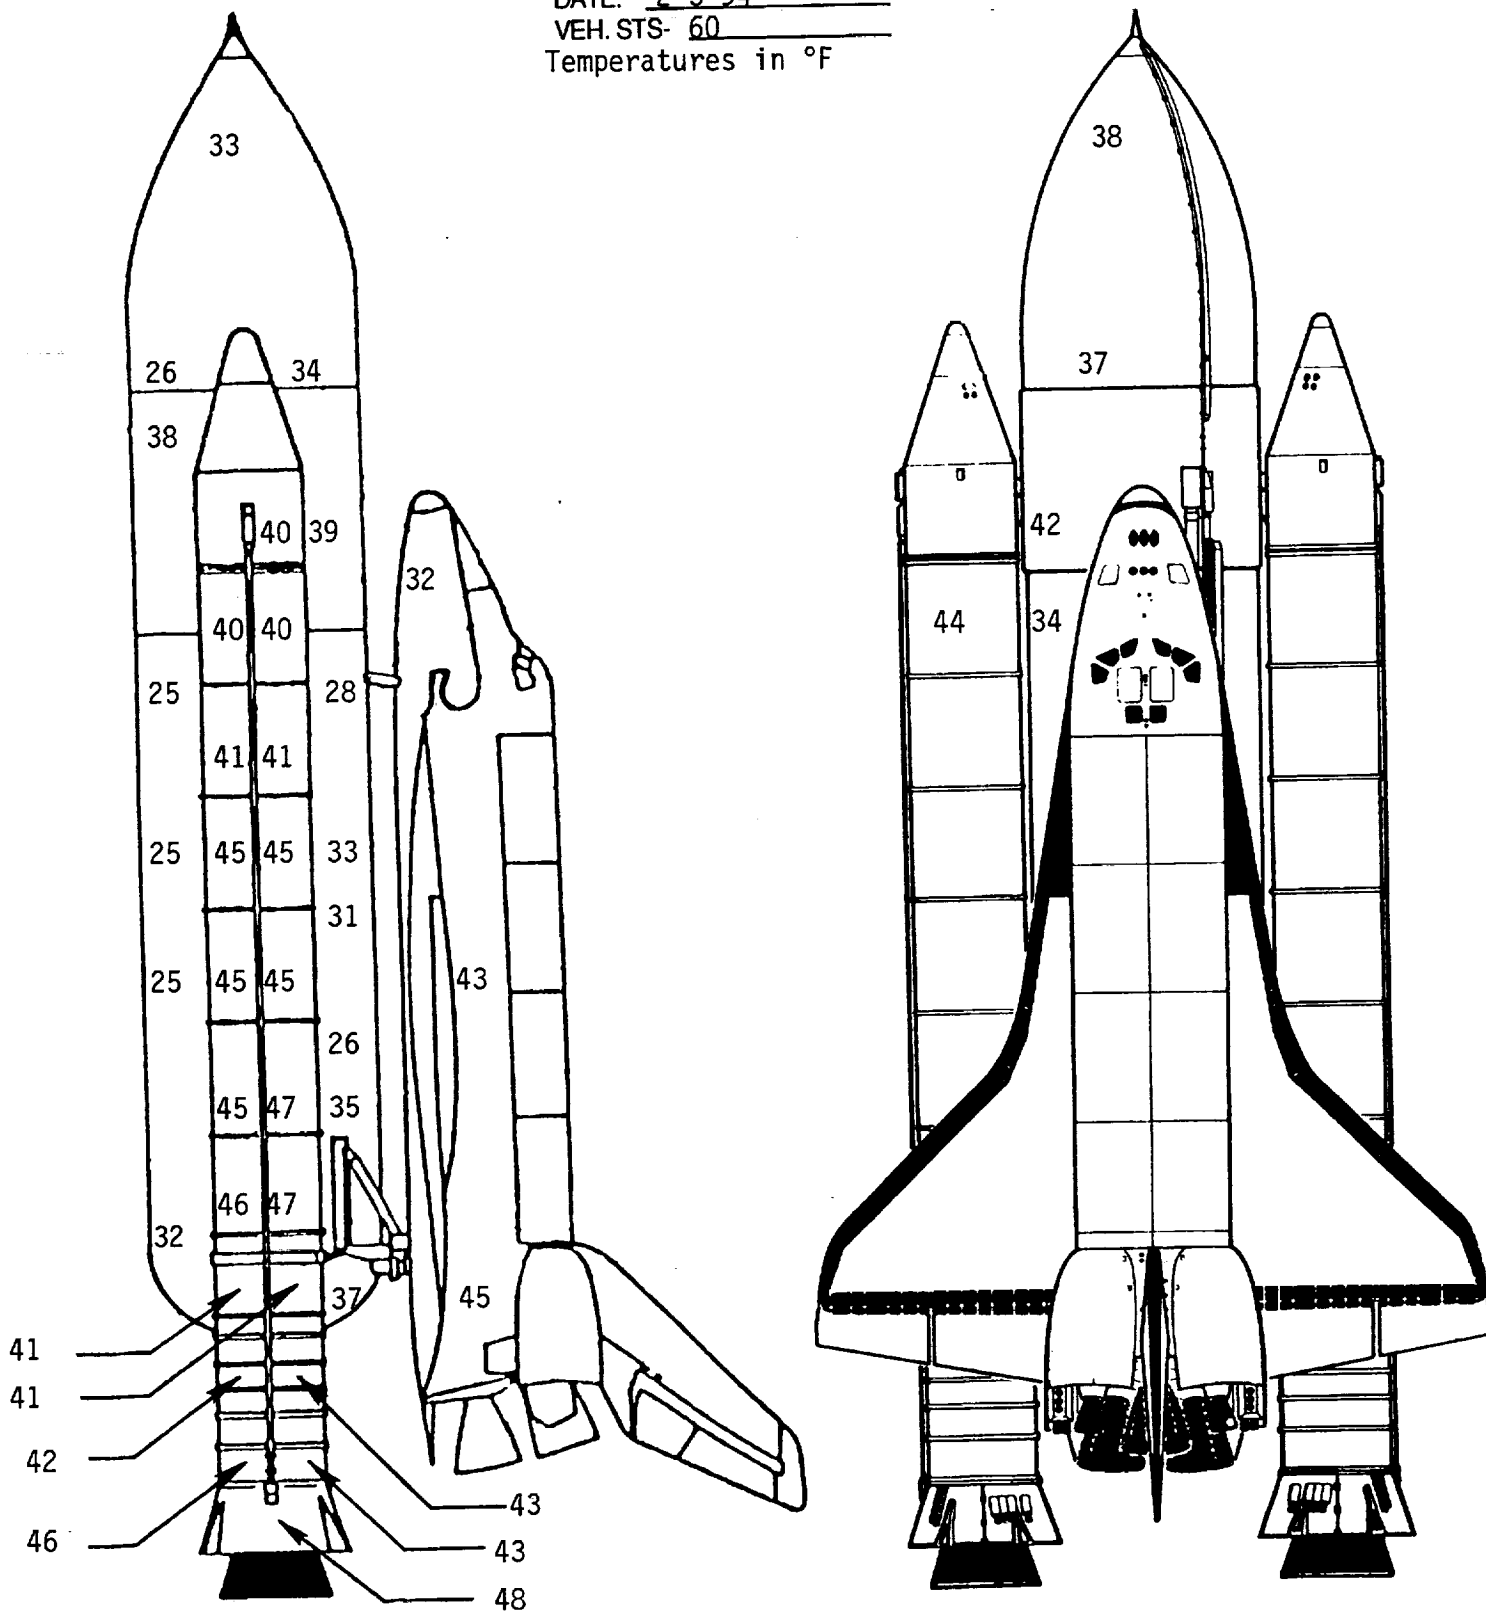
FIGURE 1. **SSV INFRARED SCANNER SURFACE TEMPERATURE SUMMARY DATA**

No Orbiter tile or RCC panel anomalies were observed. All RCS thruster paper covers were intact. Due to the prevailing weather conditions, somewhat greater than usual ice and frost accumulations were present at the SSME #1 and #2 heat shield-to-nozzle interfaces. An infrared scan revealed no unusual temperature gradients on the base heat shield or engine mounted heat shields.

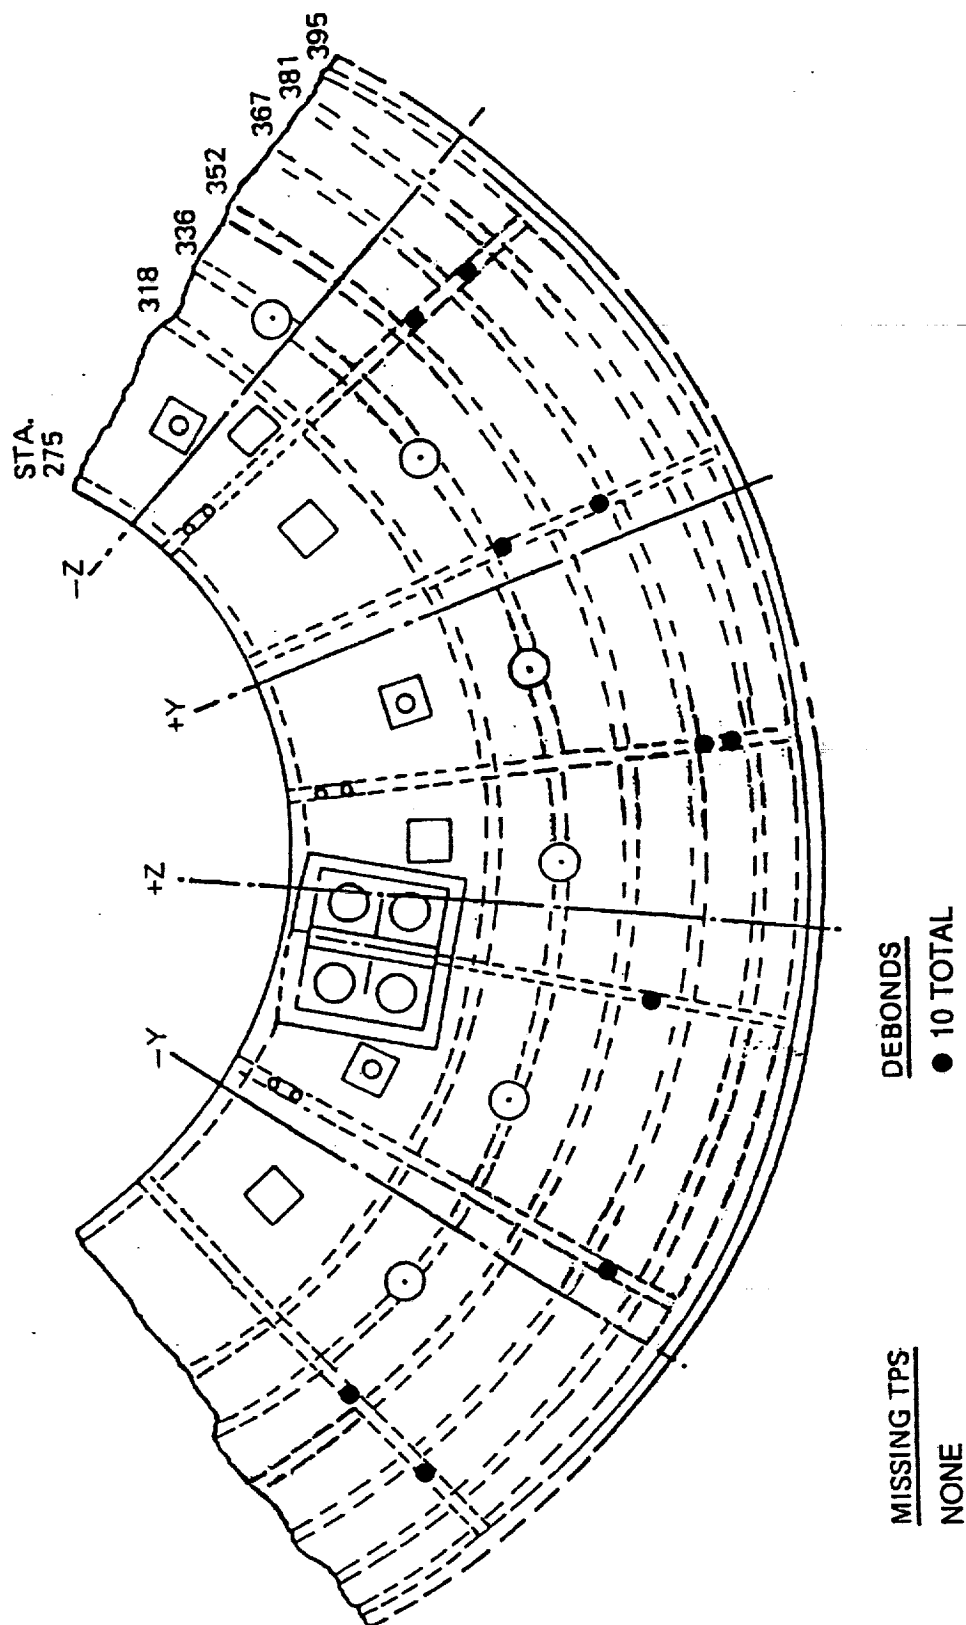
STS-60
FIGURE 4. RIGHT SRB FRUSTUM

The RH frustum was missing no TPS but had 10 MSA-2 debonds over fasteners. There was virtually no blistering of the Hypalon paint with the exception of minor localized blistering along the 395 kick ring. All BSM aero heat shield covers were locked in the fully opened position (Figure 4).

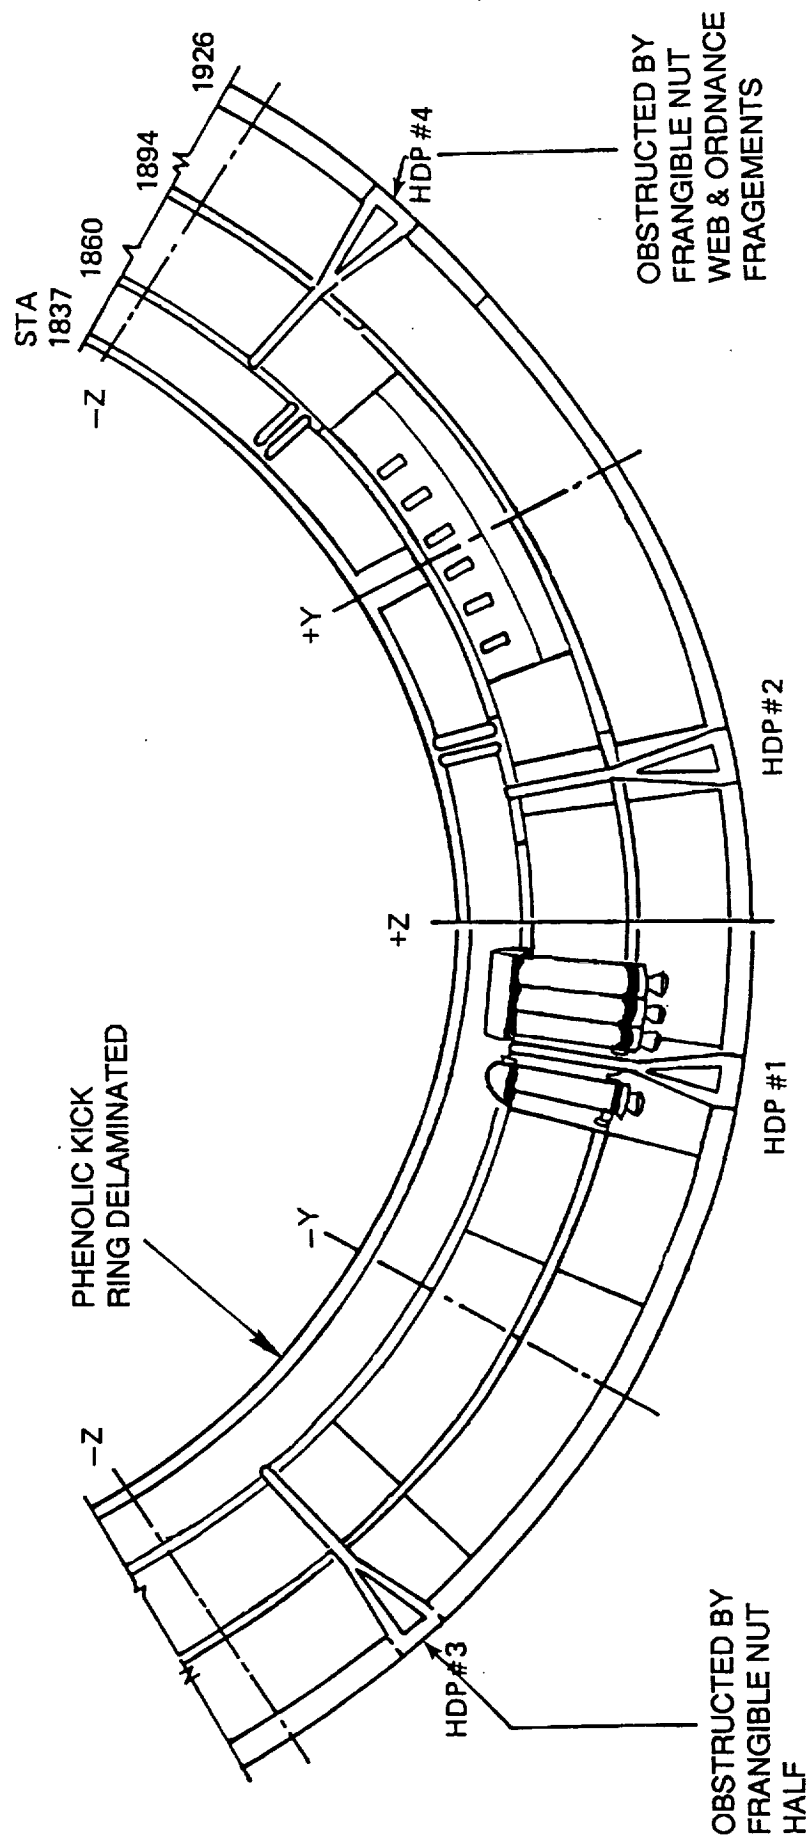
STS-60
 FIGURE 5. RIGHT SRB AFT SKIRT EXTERIOR TPS

The phenolic material on the kick ring was delaminated. Aft skirt acreage TPS was generally in good condition. Hypalon paint was blistered/missing from the BTA closeouts (Figure 5).

HDP #1 and #2 Debris Containment System (DCS) plungers were seated and appeared to have functioned properly. The HDP #3 DCS plunger was obstructed by a frangible nut half. Although launch films showed no debris falling from the DCS/stud hole at lift off, post flight disassembly of the Debris Containment System revealed a retention of only 53 percent. The ordnance fragments may have been lost at water impact. The HDP #4 DCS plunger was obstructed by a frangible nut web and small ordnance fragments. EPON shim material is no longer bonded to the HDP #3 and #4 aft skirt structure.

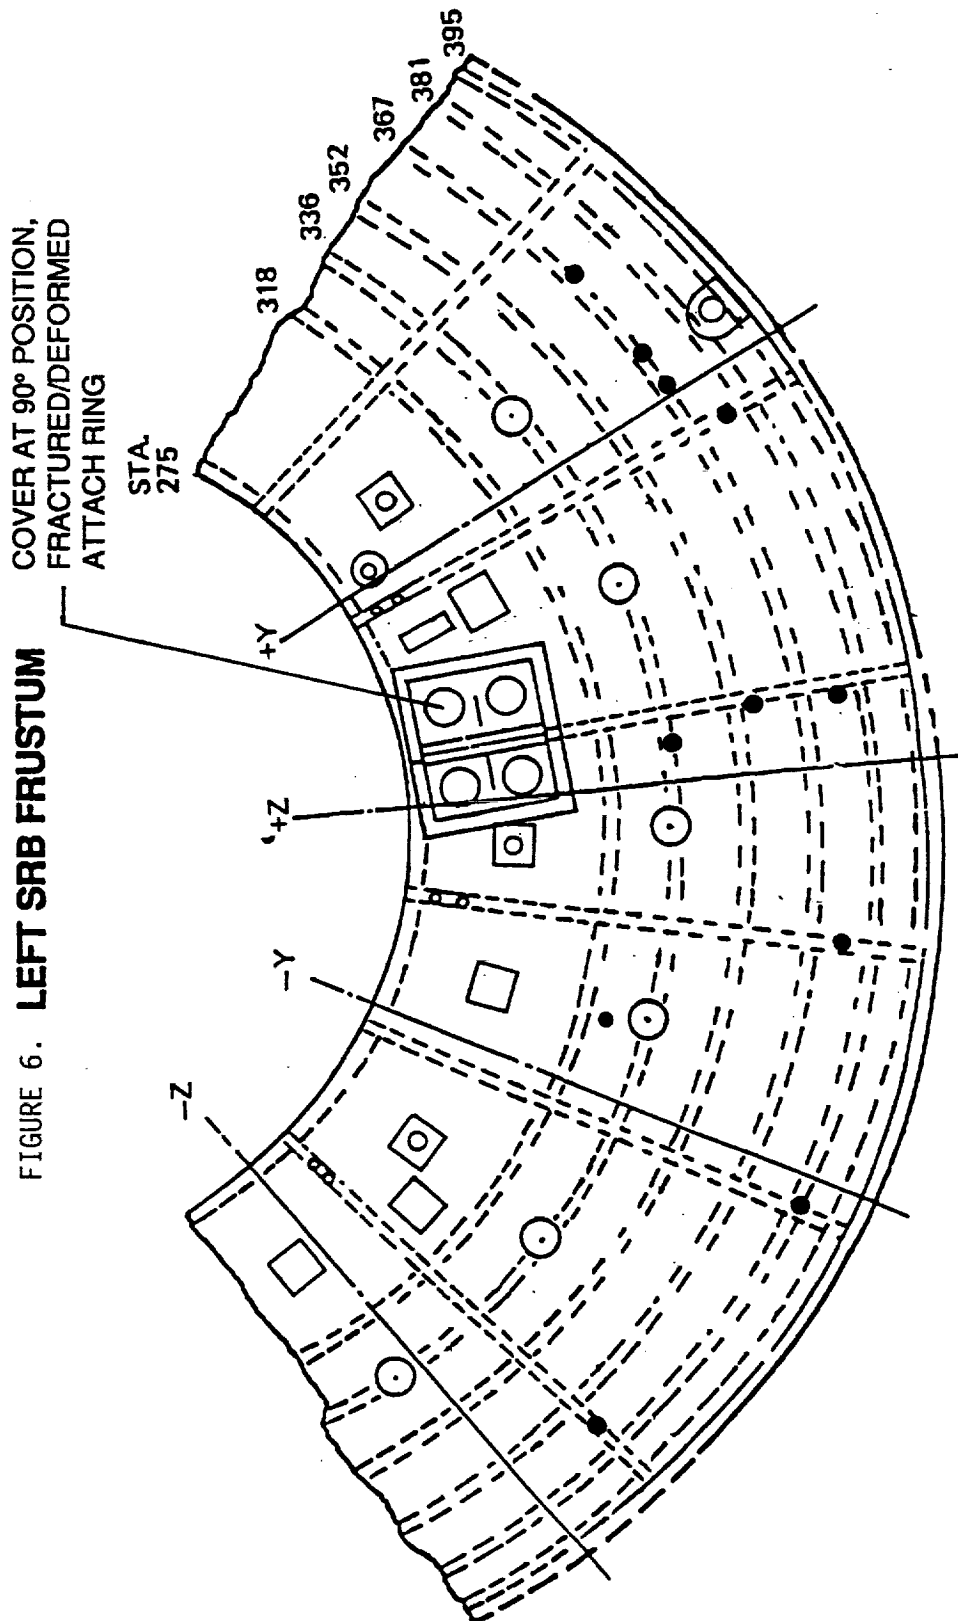
STS-60
FIGURE 6. LEFT SRB FRUSTUM

The LH frustum was missing no TPS but had 11 MSA-2 debonds over fasteners. There was virtually no blistering of the Hypalon paint with the exception of minor localized blistering along the 395 ring (Figure 6). All BSM aero heat shield covers had locked in the fully opened position. However, the upper right cover was bent backward to the 90 degree position and the attach ring had been deformed/fractured by parachute riser entanglement.

MISSING TPS
NONE

DEBONDS
● 11 TOTAL

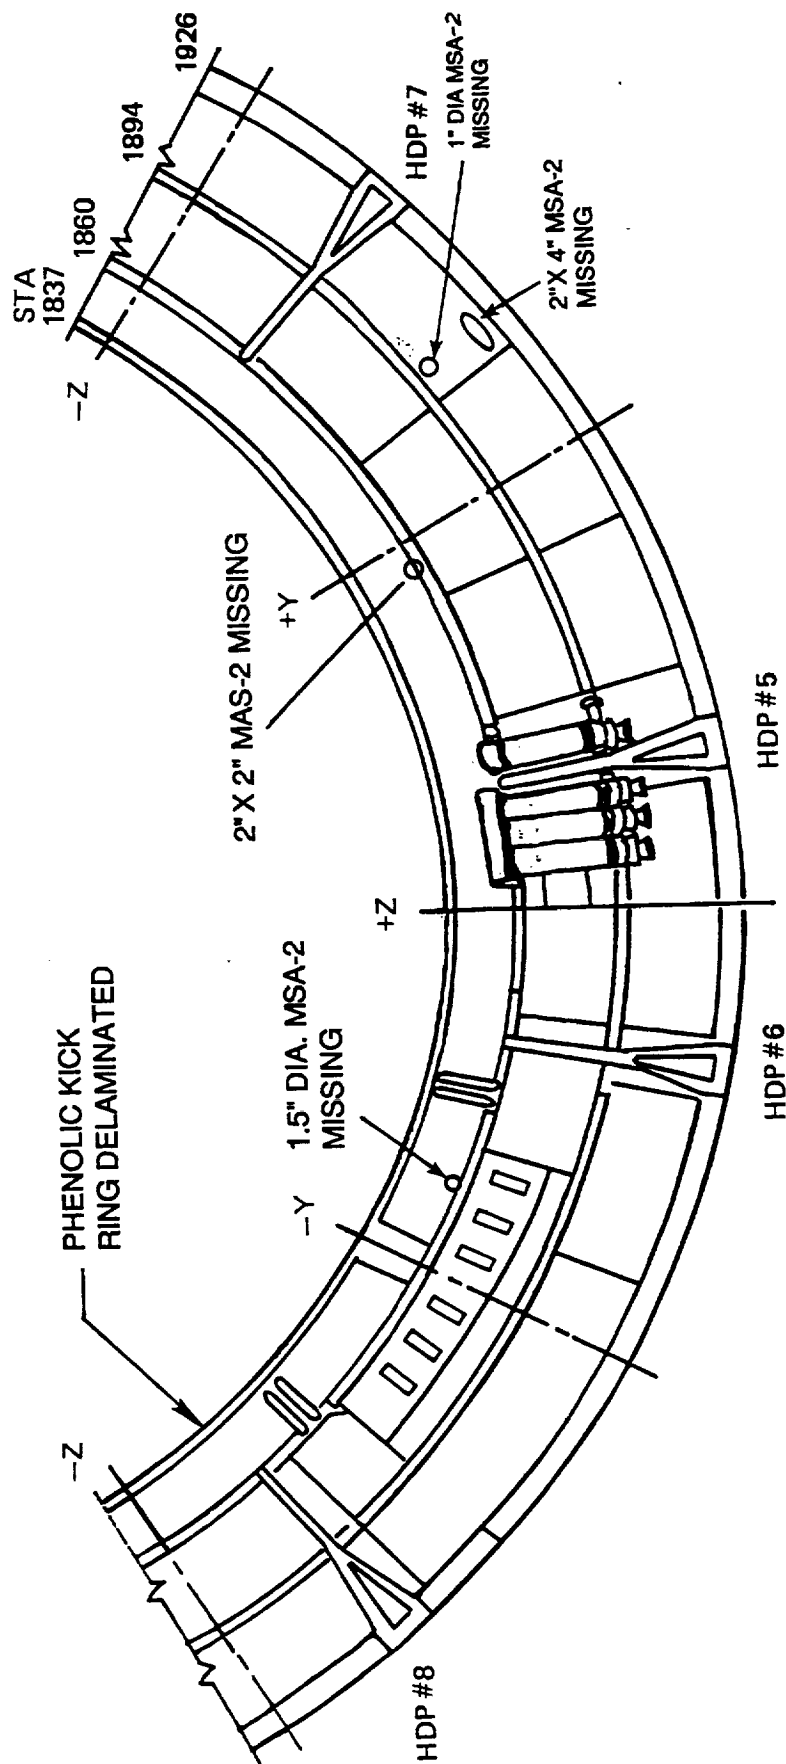
FIGURE 7. LEFT SRB AFT SKIRT EXTERIOR TPS

The phenolic material on the kick ring was delaminated. Aft skirt acreage TPS was generally in good condition, though MSA-2 was missing from four places on the 1860 ring frame and near the HDP #7 foot (Figure 7). The largest area of missing TPS measured 4" x 2". No significant amount of BTA was used on the aft skirt closeouts. A greater than usual amount of instafoam, typically applied at the launch pad, was missing from the aft skirt aft ring. Exposed sections of K5NA were sooted and showed signs of heating.

ALL DCS PLUNGERS
SEATED PROPERLY

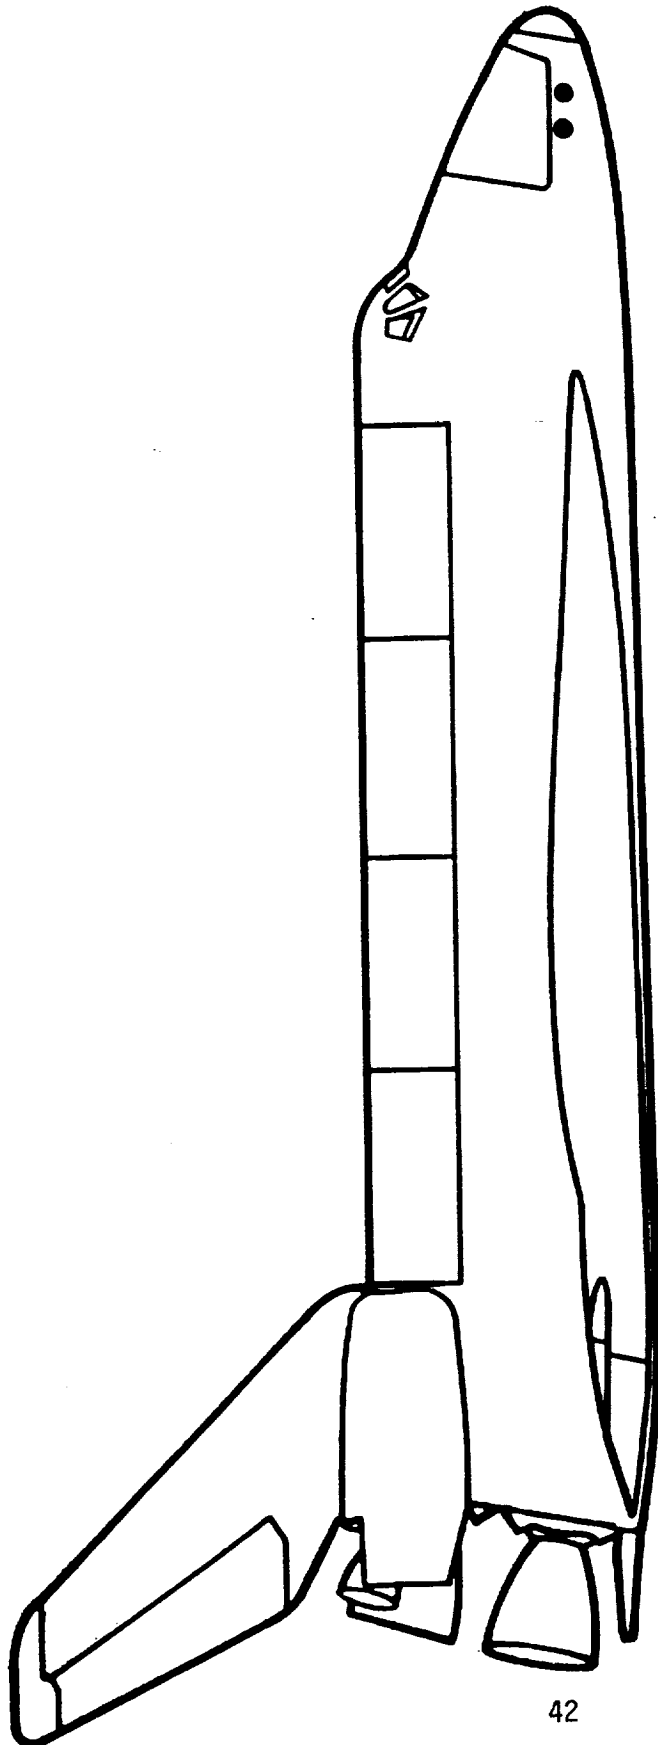
FIGURE 9. **DEBRIS DAMAGE LOCATIONS**

TOTAL HITS = 2

HITS > 1 INCH = 0

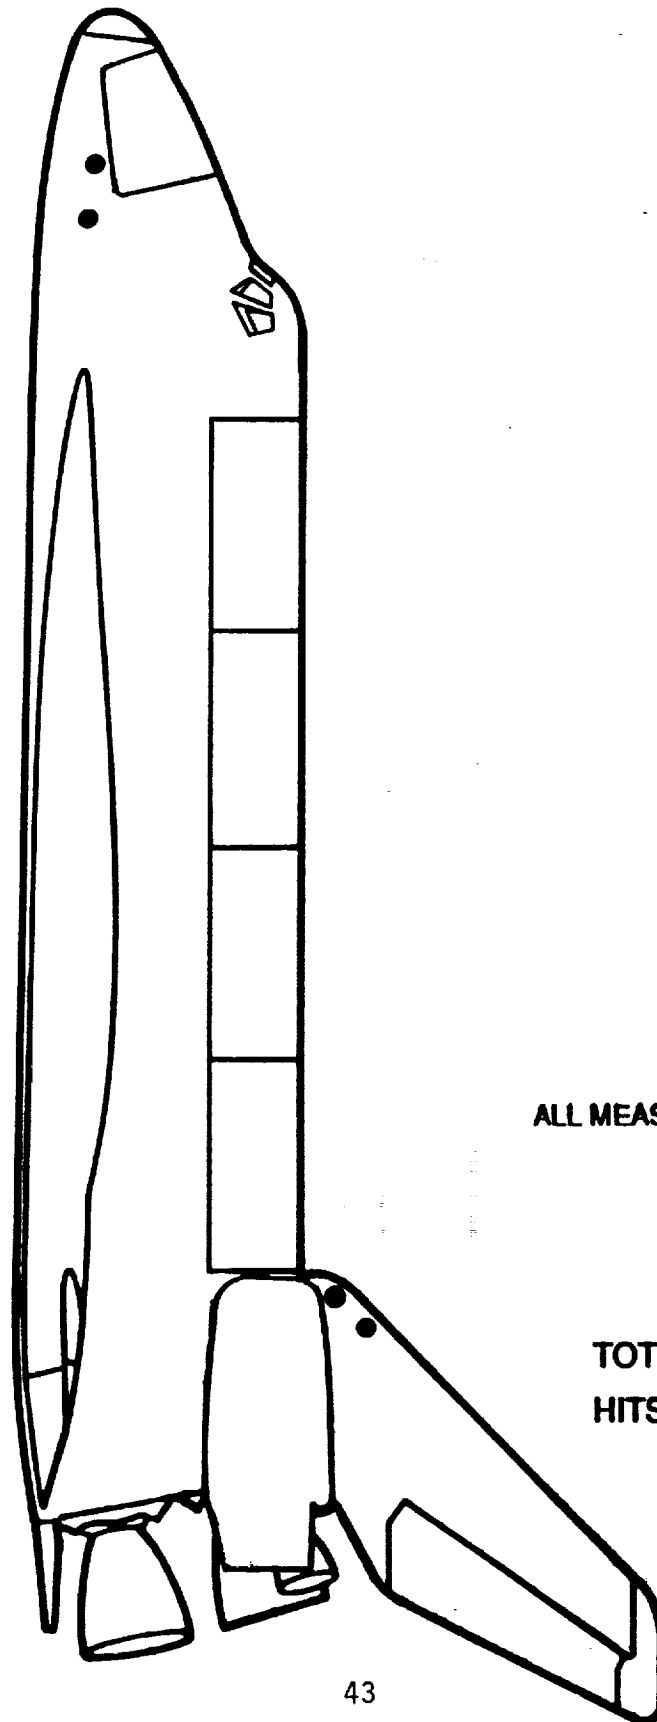
FIGURE 10. **DEBRIS DAMAGE LOCATIONS**

TOTAL HITS = 4

HITS > 1 INCH = 0

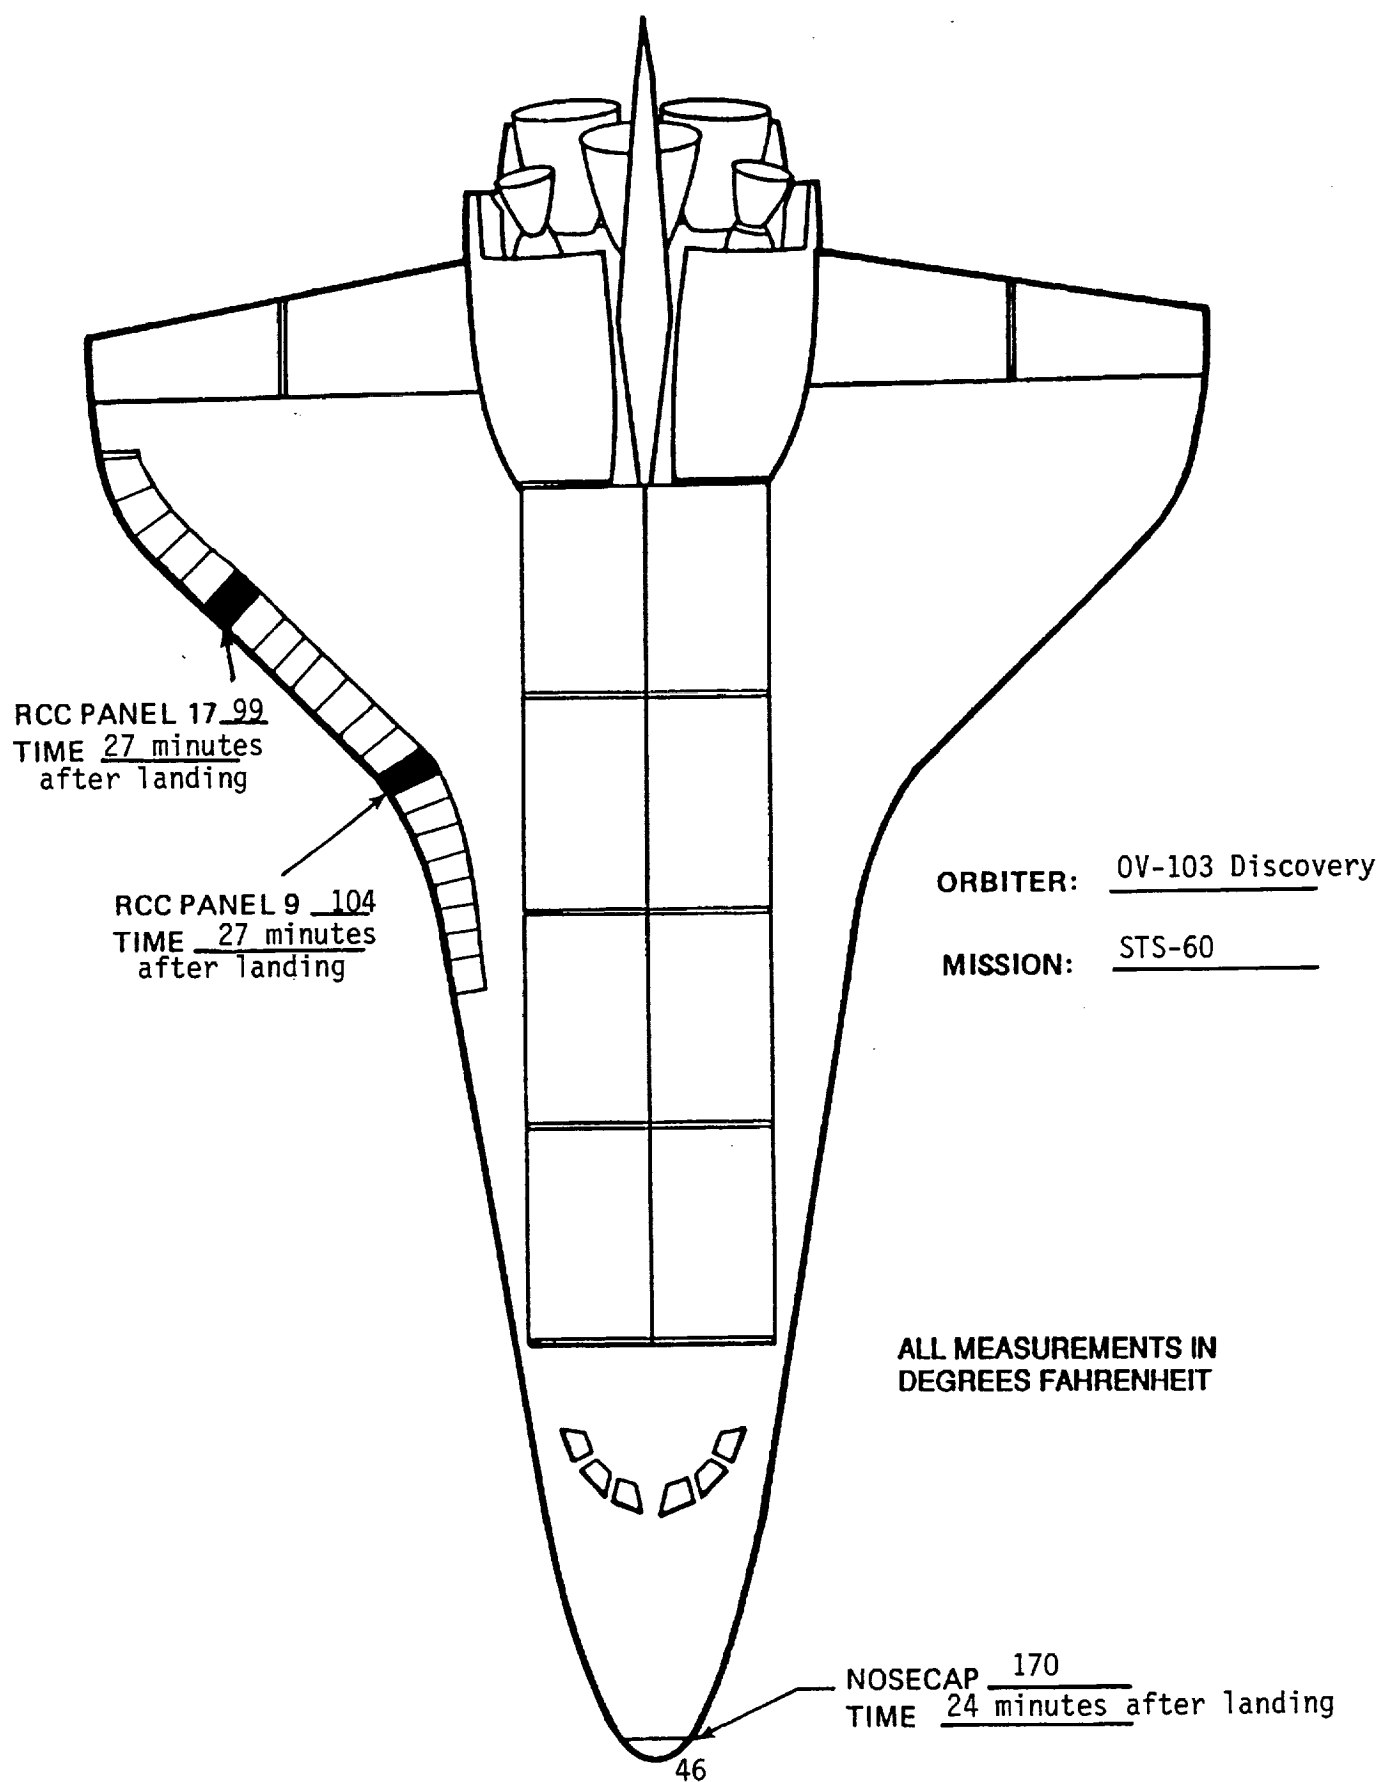
FIGURE 12. **STS-60 RCC TEMPERATURE MEASUREMENTS AS
RECORDED BY THE SHUTTLE THERMAL IMAGER**

The Shuttle Thermal Imager (STI) was used to measure the surface temperatures of several areas on the vehicle (per OMRSD V09AJ0.095). Twenty-four minutes after landing, the Orbiter nose cap RCC was 170 degrees Fahrenheit. Twenty-seven minutes after landing, the RH wing leading edge RCC panel #9 was 104 degrees F and panel #17 was 99 degrees F (Figure 12).

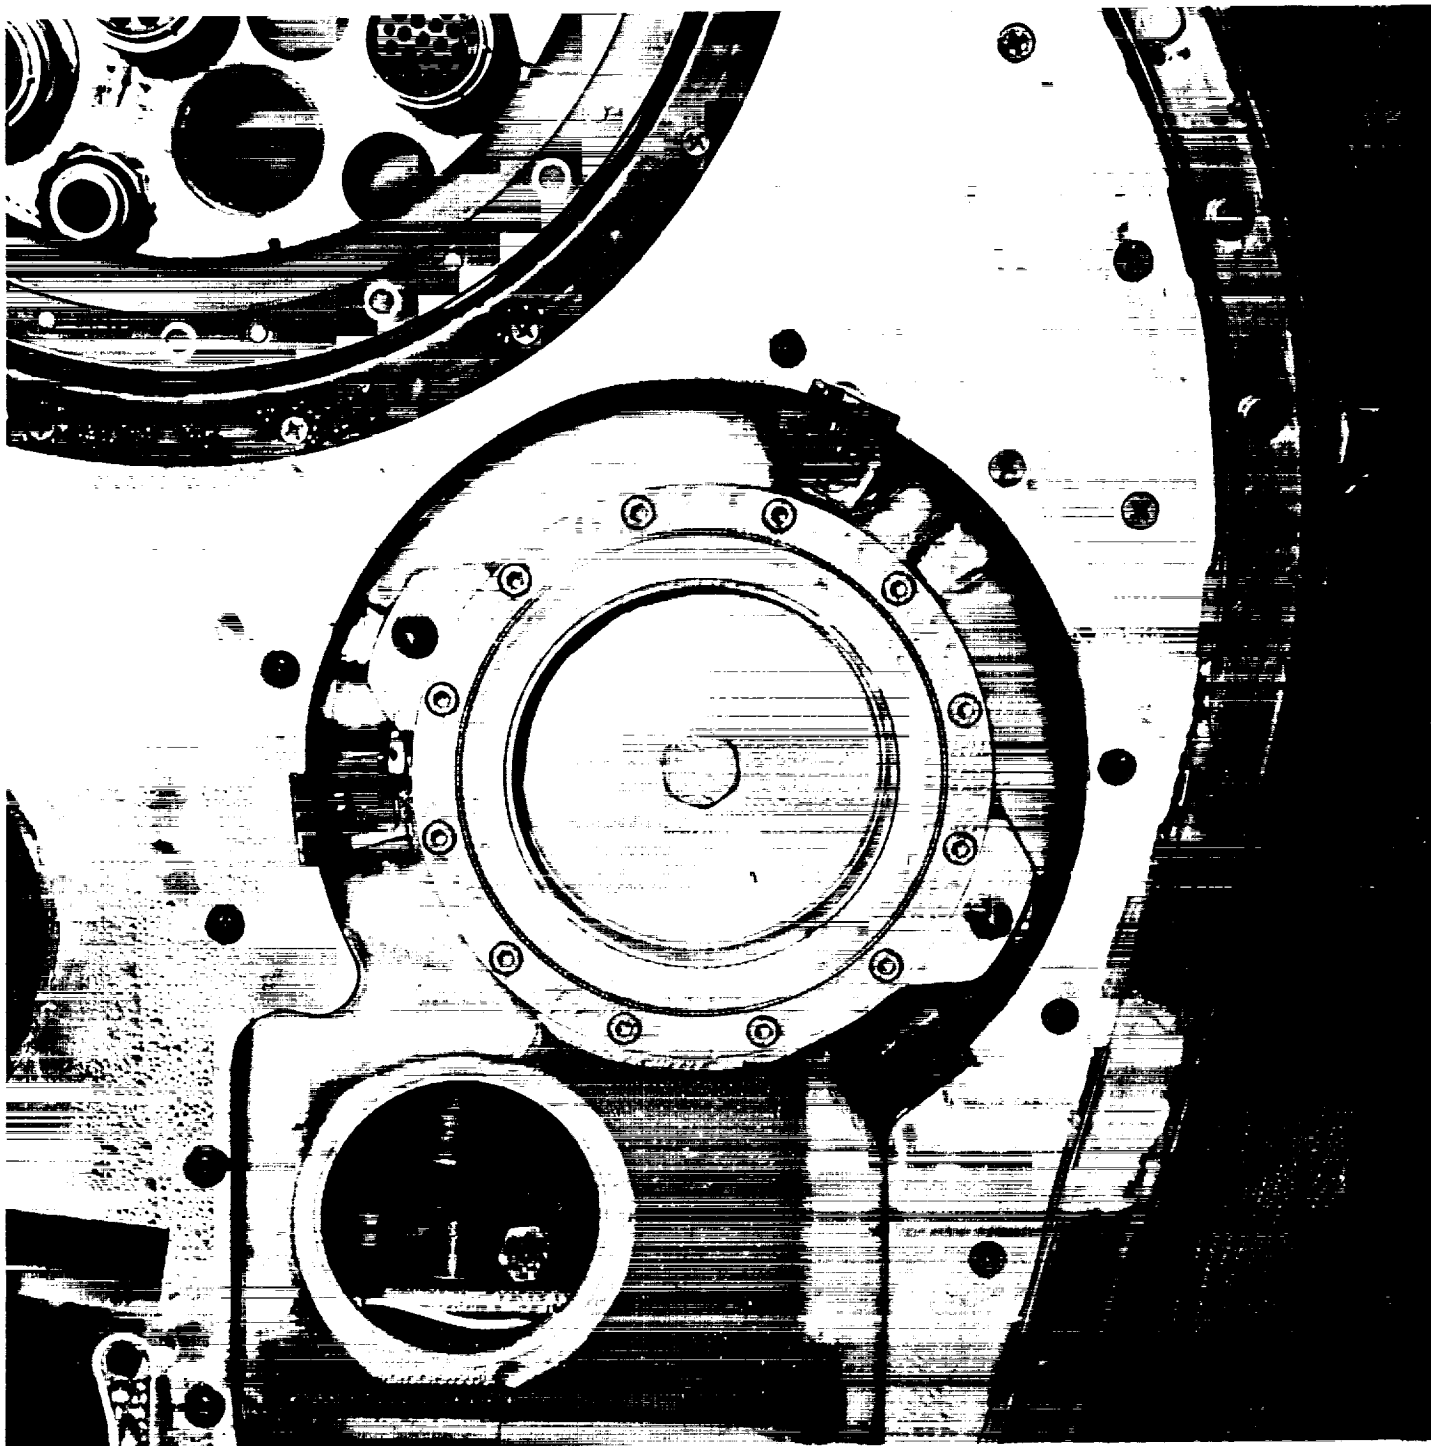
No significant amounts of ET foam or red purge seal adhered to the LH2 ET/ORB umbilical plate near the LH2 4-inch line flapper valve.
